**SITE ASSESSMENT AND
BASELINE CONDITIONS REPORT**
Forest Edge Estates Homeowner Association
Basin Assessment

Coralville, Iowa | August 22, 2019

Snyder & Associates, Inc. Project No. 119.0428

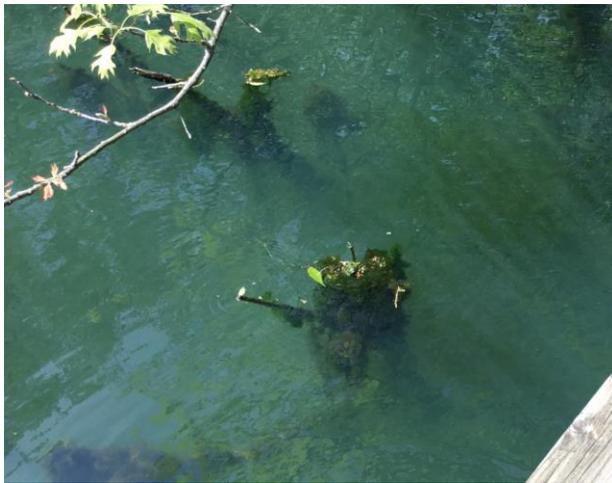
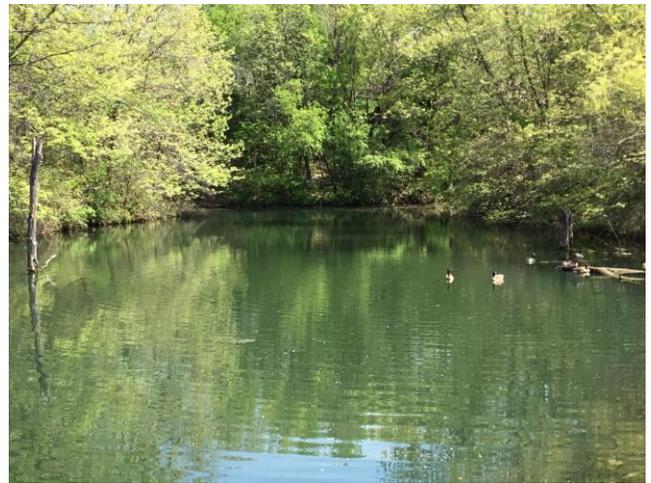
Information provided does not provide information on grading depths of pond. The normal water level is anticipated around Elev. 749.60 based on storm sewer outlet to pond elevation near High Bluff Drive, as shown in the As Built Plans for Forest Edge Estates – Part Six, Sheet 5 of 8, dated September 9, 2006. This may of potentially been originally designed as a singular basin. Additional information and drawings would be needed to confirm when the north dam and pond was constructed. A ponds water quality is often affected by the amount of suspended sediment, nutrient levels in the pond, water flow/circulation, oxygen levels and pond depth. The pond is fairly shallow with signs of cloudy water, algae blooms and a green blue tint. This is likely due to high nutrient load from stormwater runoff and sedimentation from erosion. The higher nutrients, most commonly phosphorous and nitrogen, cause the increase in growth of algae and cyanobacteria. This high nutrient load causes a process referred to as cultural eutrophication and depletes dissolved oxygen in the water for desirable organisms and fish. These eutrophic conditions can cause an undesirable odor. Further testing of the water would be required to determine estimated nutrient load, algae or bacteria present. Cyanobacteria levels which can give the water a blue green color can be highly toxic. High levels of cynobacteria can be harmful to human health if one makes contact with or consumes the water. The State Hygienic Laboratory¹ at the University of Iowa has a Limnology² office in Coralville. They can provide a water quality evaluation and assessment. A bathymetric survey would help further define the current depth of the pond water.

Photos 3-1 & 3-2: North pond water color

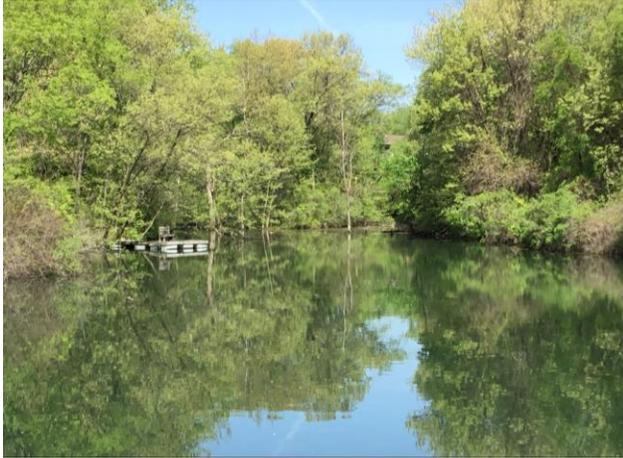
Photo 3-3: North Pond looking north from spillway

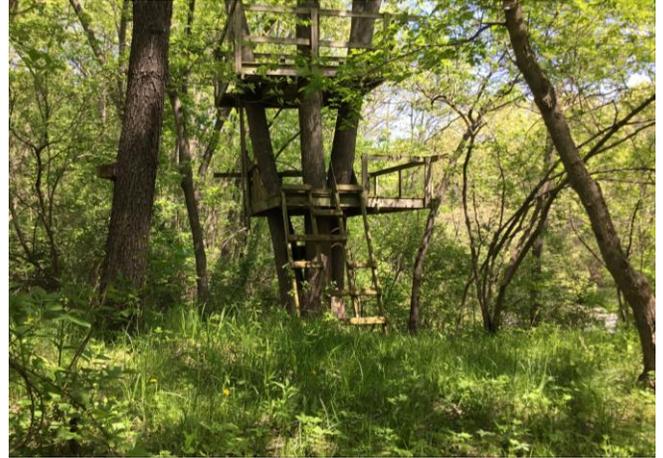
The shoreline around the north pond is primarily unmanaged woodland. Some residence are utilizing the shoreline and FEEHA property for their personal use (i.e. pier, paddle boat, tree fort, putting green, memorial bench and natural trails). There are no on site visual identifiers for residents to know where private property and the FEEHA property meet. Access points to the FEEHA are also not clearly defined or marked. This limits access to the pond for other residents within the FEEHA.

Photo 3-4: North Pond tree fort on FEEHA property

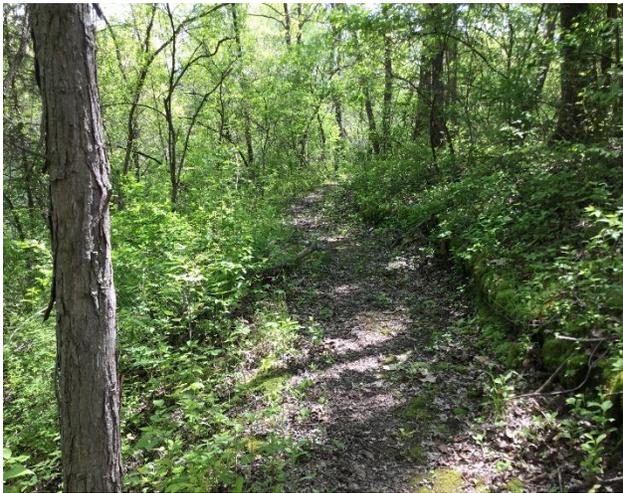
Photo 3-5: North Pond natural trail on FEEHA

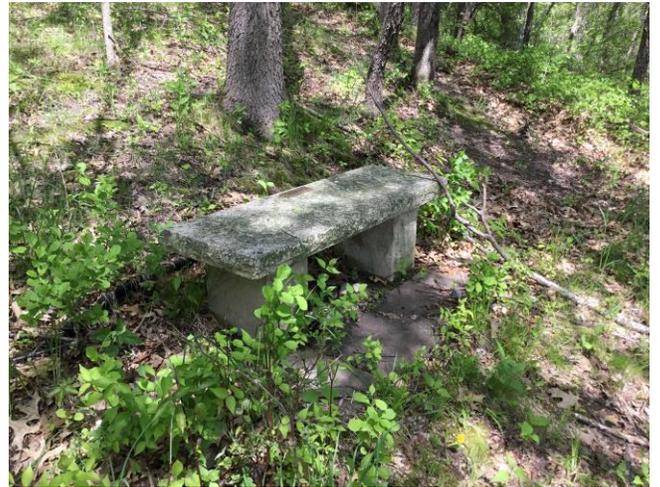
Photo 3-6: North Pond bench on FEEHA property

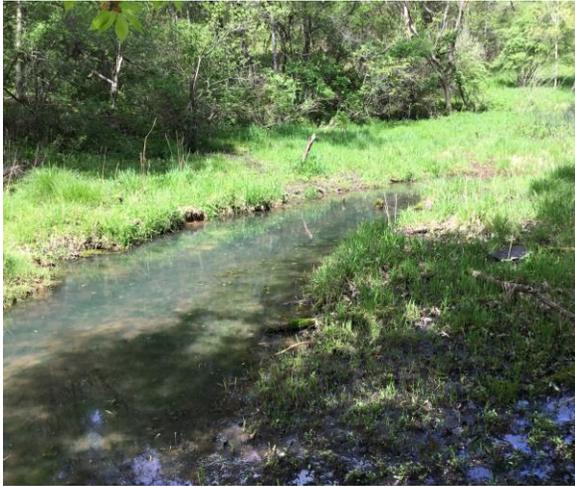
Based on Construction Plans for Forest Edge Estates – Part Two, Sheet 1 of 6, dated June 30, 1997 the pond was originally about 20 feet in depth (Elev. 708). The normal water level is anticipated around Elev. 728.00 based on drop inlet structure with trash rack and baffle elevation on south east edge of pond; as shown in the As Built Plans for Forest Edge Estates – Part Two, Sheet 4 of 6, dated February 11, 1998. The pond is currently fairly shallow with signs of sedimentation, floating sediment and algae blooms. These signs are often associated with cultural eutrophication which depletes dissolved oxygen in the water for desirable organisms and fish. These eutrophic conditions can cause an undesirable odor. An orange coloration at the north pond inlet into the south pond was also noted. Further testing of the water would be required to determine estimated nutrient load, algae or bacteria present. This is likely due to high nutrient load from stormwater runoff and sedimentation erosion. Similar to the North Pond laboratory testing of the water would be required to determine estimated nutrient load, algae or bacteria present. A bathymetric survey would help further define the current depth of the pond water.

Photo 3-7: South Pond sedimentation at north End of pond

- A bathymetric survey would help further define the current depth of the pond water. This would help the FEEHA understand how much sedimentation has occurred in the ponds; as well as current pond depth. The pond depth can affect what solutions are feasible in addressing pond oxygen levels and algae growth, such as aeration fountains.

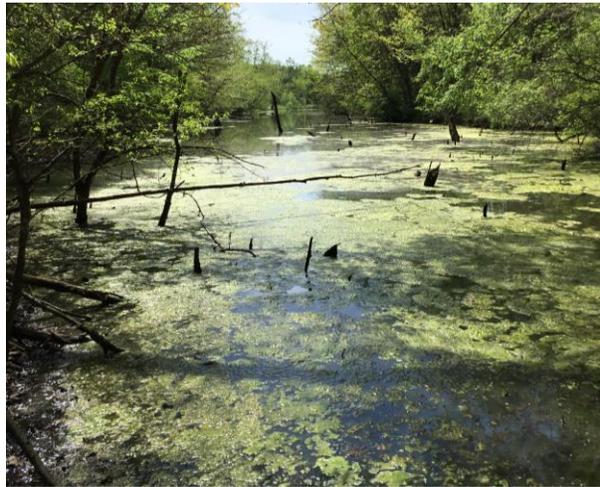
Photo 3-8: South Pond looking south from north pond inlet

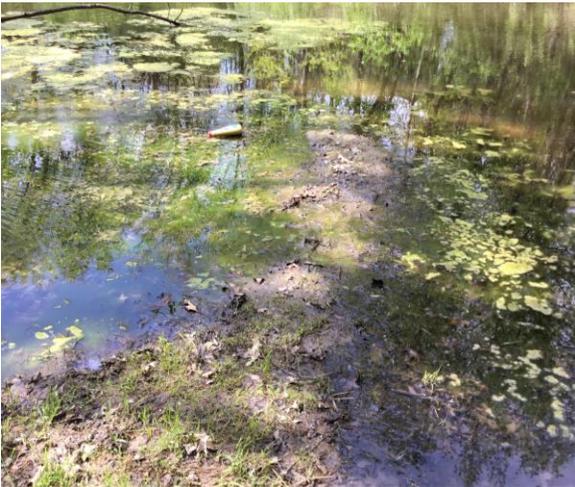
Photo 3-9: South Pond sedimentation

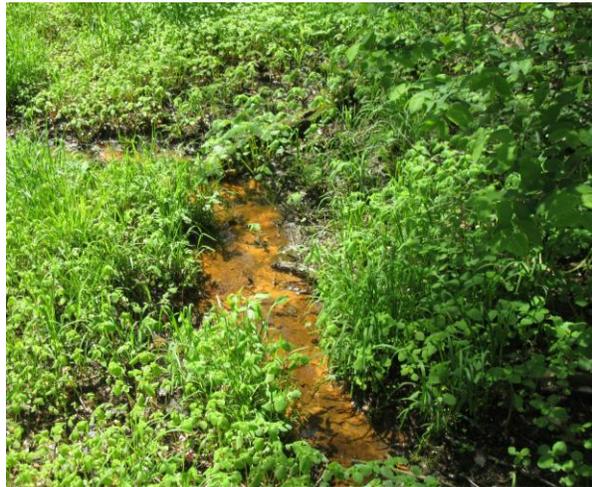
Photo 3-10: Orange Substance at North Pond Inlet to South Pond

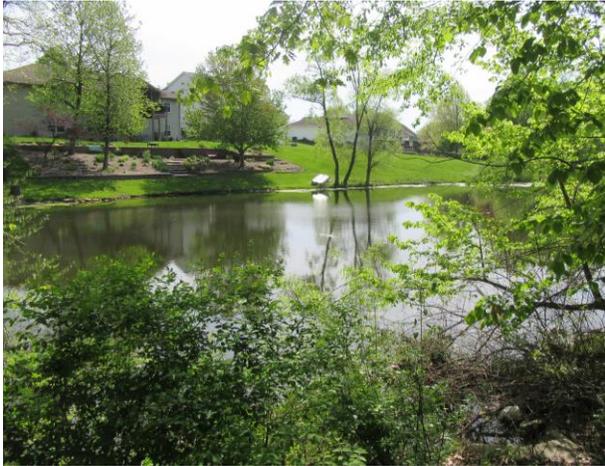
Photo 3-11: South Pond looking southeast from western shoreline

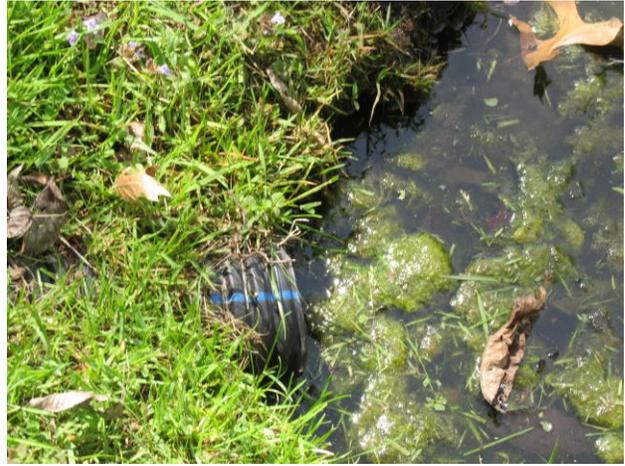
Photo 3-12: Roof subdrain from private residence

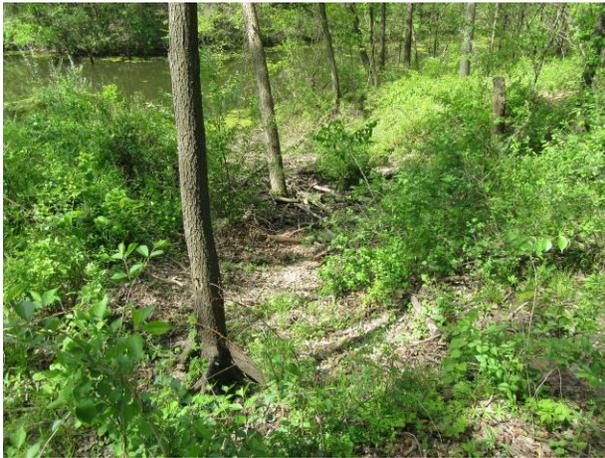
Photo 3-13: South pond surface drainage erosion and debris

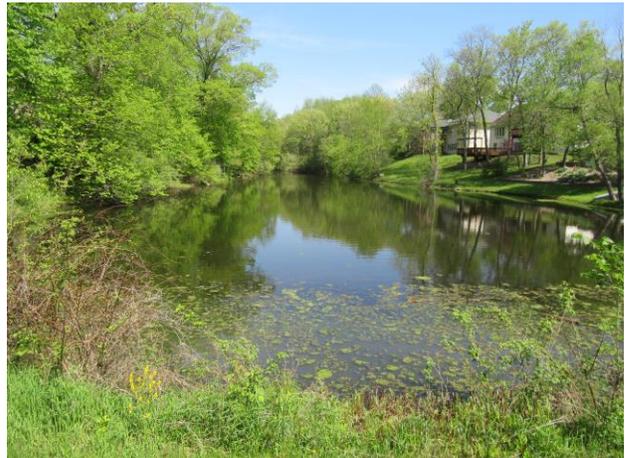
Photo 3-14: South Pond looking north from dam

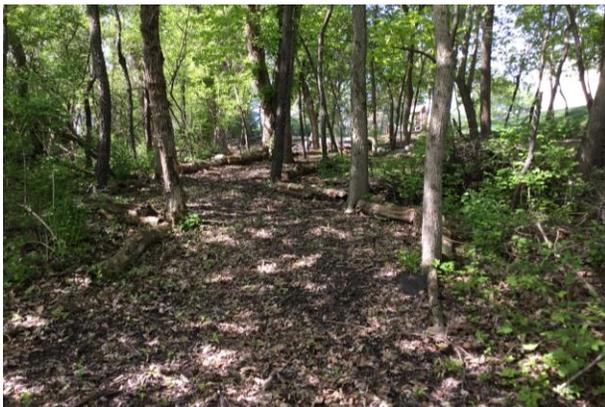
Photo 3-14: Wooded Area with natural trail west shore

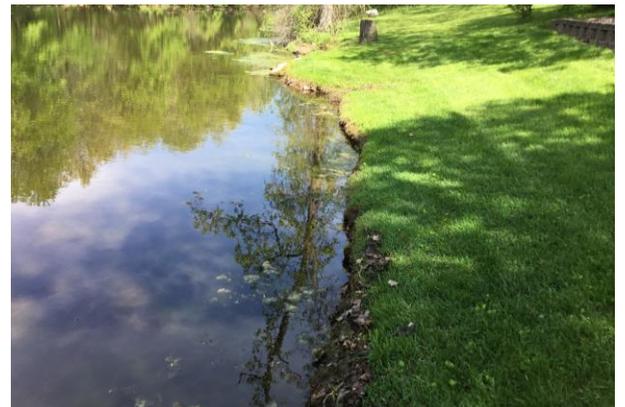
Photo 3-15: Signs of erosion along areas mown up to edge of pond

- Educate homeowners within the neighborhood concerning their own practices that can negatively affect pond health. (e.g. mowing up to pond edge, over fertilization of lawns and gardens, slope erosion, chemicals and undesirable pollutants that can wash from driveways into storm sewer system).

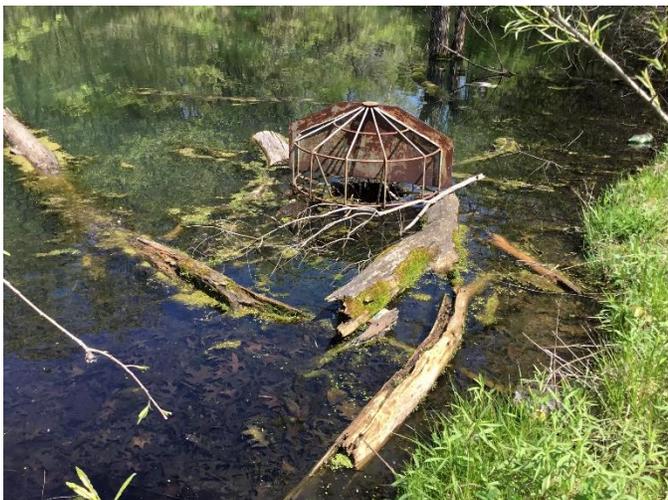
The principal spillway of the pond is a 24" reinforced concrete riser pipe with a baffle plate and a trash rack. Some algae growth and fallen woody debris is present around the principal spillway, but otherwise debris accumulation is not currently a concern. The spillway was observed to be flowing normally. The riser pipe, trash rack, and baffle plate are showing age aesthetically but appear to be in good structural condition. The pipe appears to be structurally sound, as no sinkholes or other faults were observed at the outlet. Sediment has built up around the structure and is flowing downstream into the South Pond during high water levels.

Photo 4-1: North Pond spillway inlet structure

- Ensure that the trash racks and surrounding areas of the principal spillways are cleared of debris and vegetation.
- Maintain a clear outlet free from fallen trees and other debris.
- Brush and trees should not be permitted along the top of the embankment as their root systems can create paths for water seepage, especially after roots decay. This seepage could contribute to eroding of the embankment.
- Monitor outlets for additional scouring and maintenance needs.

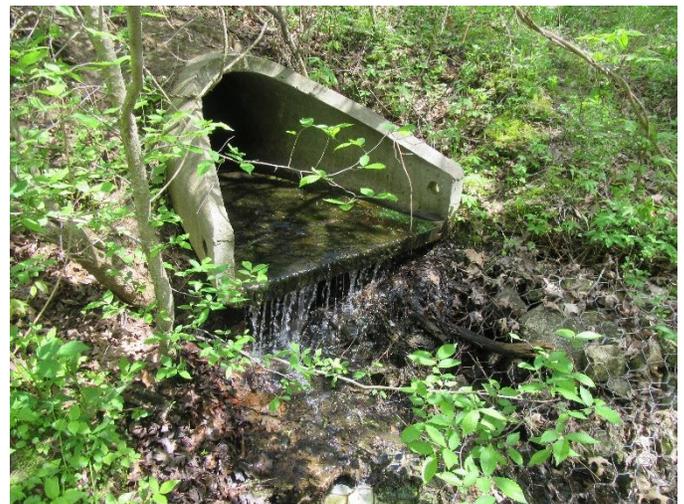
The outlet of the pond below the embankment is free from debris and appears to be flowing freely. Trees are present above the outlet, which could be a risk factor for debris accumulation around the outlet but are not currently causing issues. The outlet has a small drop onto the downstream channel, which is causing a small scour pool to develop. Gabion netting with small rocks has been placed to mitigate further scour. The scour pool appears stable. Although this currently appears to be stabilized if undermining were to continue the structure can fail. Continue to monitor this for further scouring is recommended.

Photo 4-2: North Pond spillway outlet structure

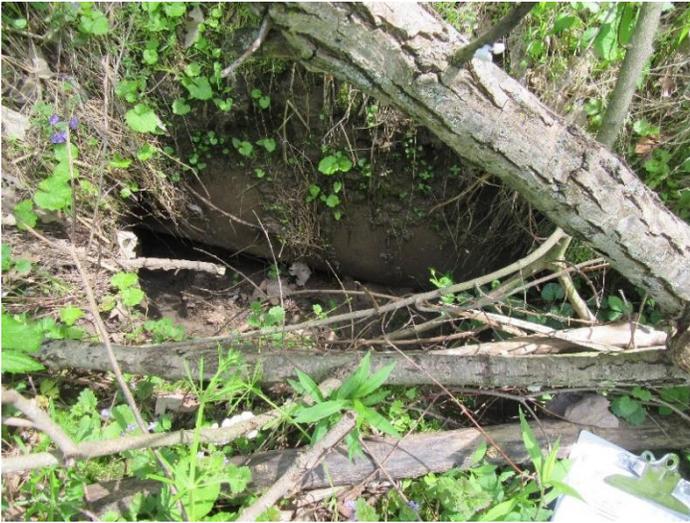
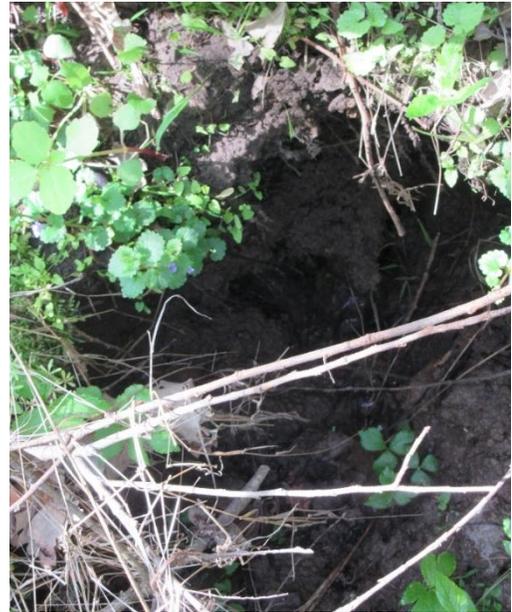
The downstream slope had a few spots of concern. Principally, three to four large sinkholes were observed near the outlet of the principal spillway. In one location, the concrete of the outlet pipe was visible. It is unclear upon initial inspection what the root cause of these issues are. It does not appear likely that the outlet pipe is cracked or leaking in a location which would cause concerns under normal flow conditions, as water was not visible running in the sinkholes. If cracks or leakage from the pipe or pipe joints were to be observed, it may be during a high flow event when the pipe is flowing full. These sinkholes could be caused by internal seepage through the dam adjacent to the pipe. These sinkholes do not appear to be a surface erosion issue as the slope is sufficiently vegetated adjacent to the sinkholes and no overland rills are present.

Photo 4-4: Sinkhole around South Pond Outlet Pipe

The dam does not appear to have internal embankment drains upon initial inspection, as outlets were not visible. As-built drawings did not record the presence of internal drainage systems. Active seepage was not observed, however, the sinkholes described in the preceding section may indicate that seepage has occurred.

It is recommended that further inspection be performed to identify the cause of the sinkholes adjacent to the outlet pipe of the south pond. CCTV sewer inspection could be utilized to assess whether cracks or other deformities are present within the pipe. If cracks or seepage from the pipe itself are the cause of the sinkholes, it may be pertinent to repair the cracks or replace the outlet pipe. If the pipe is not observed to be deformed, a geotechnical investigation is recommended to identify the cause of the sinkholes. A possible solution may be to fill the sinkholes with soil and seed the slope or place revetment adjacent to the outlet to protect against erosion. However, if internal seepage issues are present within the dam, it is possible that these sinkholes may return.

The sinkholes should be periodically checked to see if they are increasing in size or otherwise worsening. If the conditions are worsening, prudent repair is recommended to prevent further issues. Likewise, the overland flow rills should be periodically inspected to see if the problem worsens.

and labor fees. Sinkhole maintenance is estimated to include topsoil backfill in the sinkholes, seeding of the filled areas, and optional placement of erosion stone and engineering fabric around the outlet of the pipe to mitigate future erosion. It is anticipated that mobilization of large equipment and labor will make up a substantial amount of the probable cost of sinkhole maintenance. The total fee to hire a contractor to perform this work is estimated to cost \$12,800.
